# **INSPECTION AND ANALYSIS OF FAILED TRANSMISSIONS**

**INTERIM REPORT  
TFLRF No. 399**

**U.S. Army TARDEC Fuels and Lubricants Research Facility  
Southwest Research Institute® (SwRI®)  
San Antonio, TX**

for  
**U.S. Army TARDEC  
Force Projection Technologies  
Warren, Michigan**

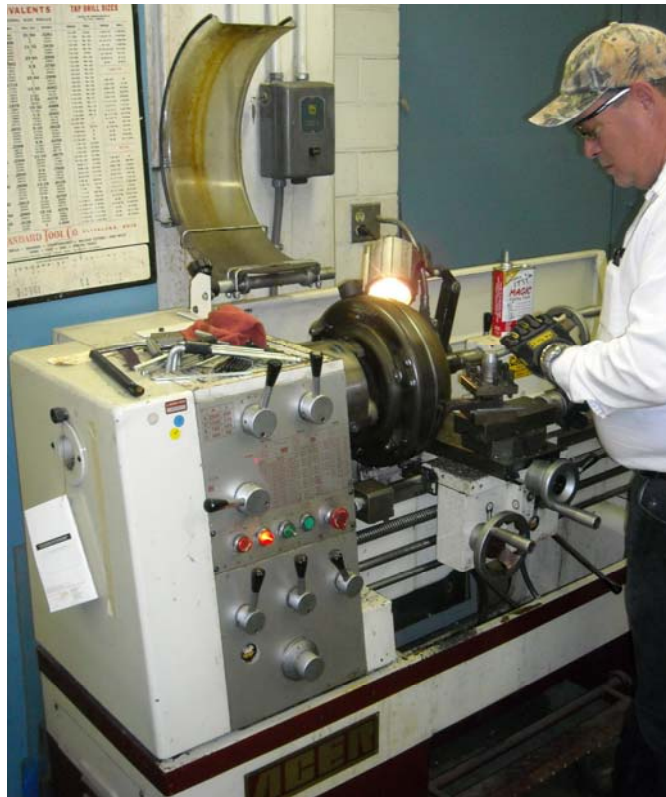
**Figure 6 - Torque Converter Mounting in Metal Lathe**

Upon completion of the initial teardown, no apparent cause for transmission malfunction was found. It was noted during disassembly that all three torque converters were discolored due to high temperatures, and ranged from lightly blued to black in color. This combined with measured maximum torque converter endplay for two of the units at or exceeding limits set by ATI, called for further investigation on torque converter condition. TFLRF staff requested permission from TARDEC to cut open each converter to assess internal condition. TARDEC granted permission, and each converter was disassembled for further analysis. Torque converter disassembly was accomplished by mounting each unit in a metal lathe and cutting the welded seam open around the circumference of its housing as shown in Figure 6.

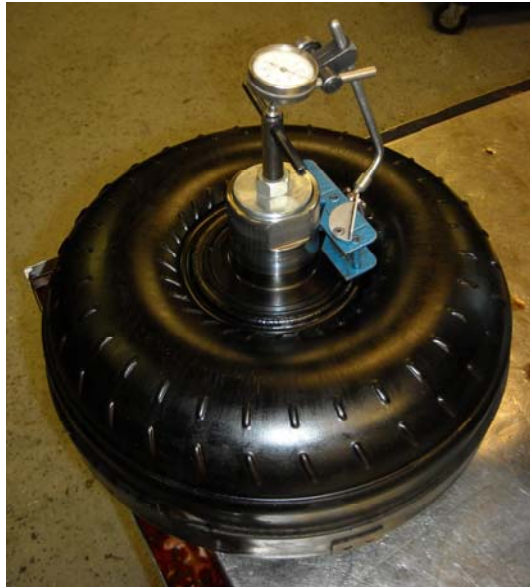
**Figure 7 - Torque Converter Endplay Measurement Apparatus**

During initial transmission disassembly, the endplay of the each converter was measured in an effort to determine the cause of failure. The measurement apparatus can be seen below in Figure 7.

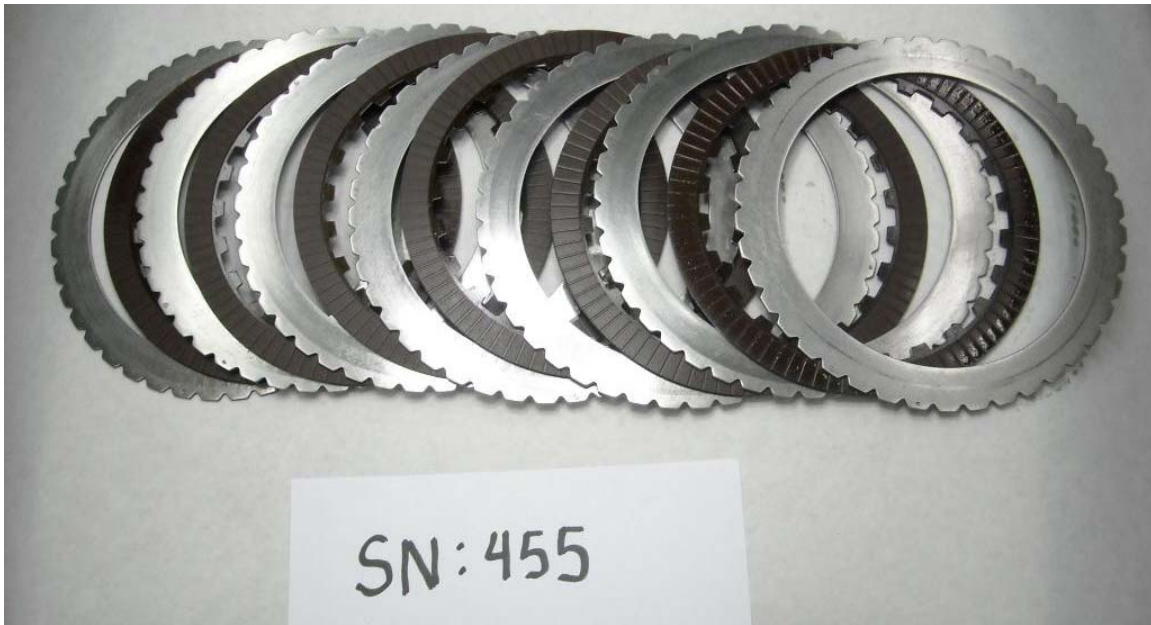
**SN455 C2 Friction Disk and Reaction Plates**

<b>C1 CLUTCH STEEL PLATES</b>	WARPAGE OF CLUTCH PLATES, HAD TO BE REMOVED BY FORCE
<b>C1 CLUTCH PAPER PLATES</b>	WARPAGE OF CLUTCH PLATES, HAD TO BE REMOVED BY FORCE, PLATES ARE DARKENED WITH SOME GLAZING
<b>C2 CLUTCH STEEL PLATES</b>	SLIGHTLY POLISHED WITH NO ABNORMAL WEAR
<b>C2 CLUTCH PAPER PLATES</b>	SLIGHT BROWN DISCOLORATION
<b>C3 CLUTCH STEEL PLATES</b>	SLIGHT POLISHING WITH SOME HEAT SPOTS
<b>C3 CLUTCH PAPER PLATES</b>	VERY SLIGHT DARKENING
<b>C4 CLUTCH STEEL PLATES</b>	SLIGHTLY POLISHED WITH NO ABNORMAL WEAR
<b>C4 CLUTCH PAPER PLATES</b>	DARKENING IN INNER RADIUS OF THE PLATES WITH PLATE IDENTIFICATION NUMBERS VISBLE
<b>C5 CLUTCH STEEL PLATES</b>	SLIGHTLY POLISHED WITH NO ABNORMAL WEAR
<b>C5 CLUTCH PAPER PLATES</b>	VERY SLIGHT DARKENING WITH PLATE IDENTIFICATION NUMBERS VISBLE
<b>THRUST WASHER</b>	LIGHT WEAR, POLISHED WITH SOME LIGHT DEPOSITS AND CORROSION
<b>BUSHINGS</b>	SLIGHT POLISHING WITH NO ABNORMAL WEAR

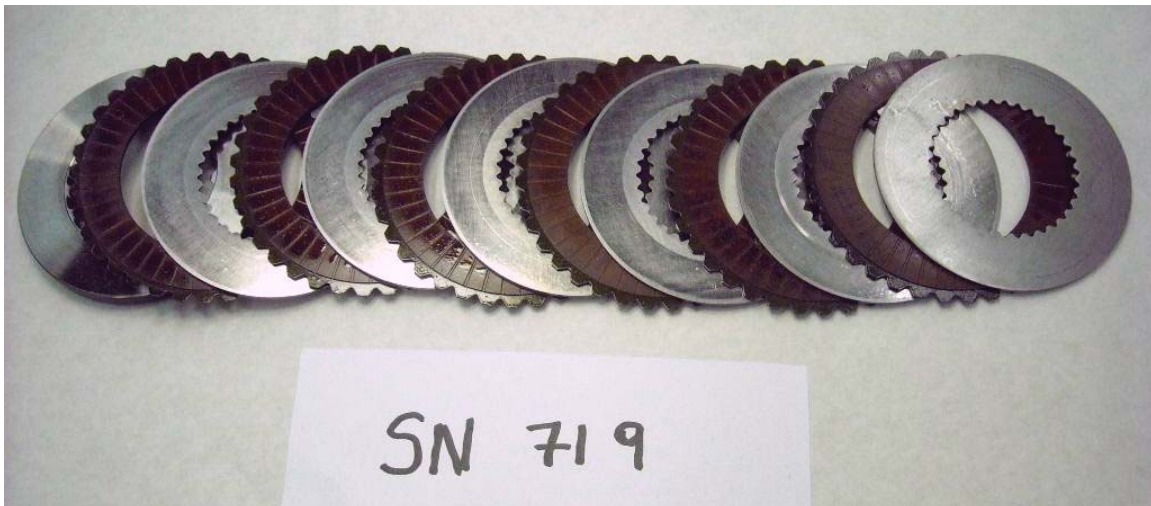
**SN719 C1 Friction Disk and Reaction Plates**

Each clutch pack (friction disk and reaction plates) is shown below in sequential order from C1 to C5. SN719 only experienced minor clutch damage, primarily C1 and C4, but was overall found to still be in operable condition.

<b>C1 CLUTCH STEEL PLATES</b>	SLIGHTLY POLISHED WITH NO ABNORMAL WEAR
<b>C1 CLUTCH PAPER PLATES</b>	VERY SLIGHT DARKENING WITH PLATE IDENTIFICATION NUMBERS VISIBLE
<b>C2 CLUTCH STEEL PLATES</b>	SLIGHTLY POLISHED WITH NO ABNORMAL WEAR
<b>C2 CLUTCH PAPER PLATES</b>	VERY SLIGHT DARKENING WITH PLATE IDENTIFICATION NUMBERS VISIBLE
<b>C3 CLUTCH STEEL PLATES</b>	POLISHED WITH NO ABNORMAL WEAR
<b>C3 CLUTCH PAPER PLATES</b>	VERY SLIGHT DARKENING WITH PLATE IDENTIFICATION NUMBERS VISIBLE
<b>C4 CLUTCH STEEL PLATES</b>	POLISHED WITH NO ABNORMAL WEAR
<b>C4 CLUTCH PAPER PLATES</b>	DARKENING IN INNER RADIUS OF THE PLATES WITH PLATE IDENTIFICATION NUMBERS VISBLE
<b>C5 CLUTCH STEEL PLATES</b>	VERY SLIGHTLY POLISHED WITH NO ABNORMAL WEAR
<b>C5 CLUTCH PAPER PLATES</b>	VERY SLIGHT DARKENING WITH PLATE IDENTIFICATION NUMBERS VISIBLE
<b>THRUST WASHER</b>	LIGHT WEAR, HAS SOME BLACK DEPOSITS
<b>BUSHINGS</b>	SLIGHT POLISHING WITH NO ABNORMAL WEAR

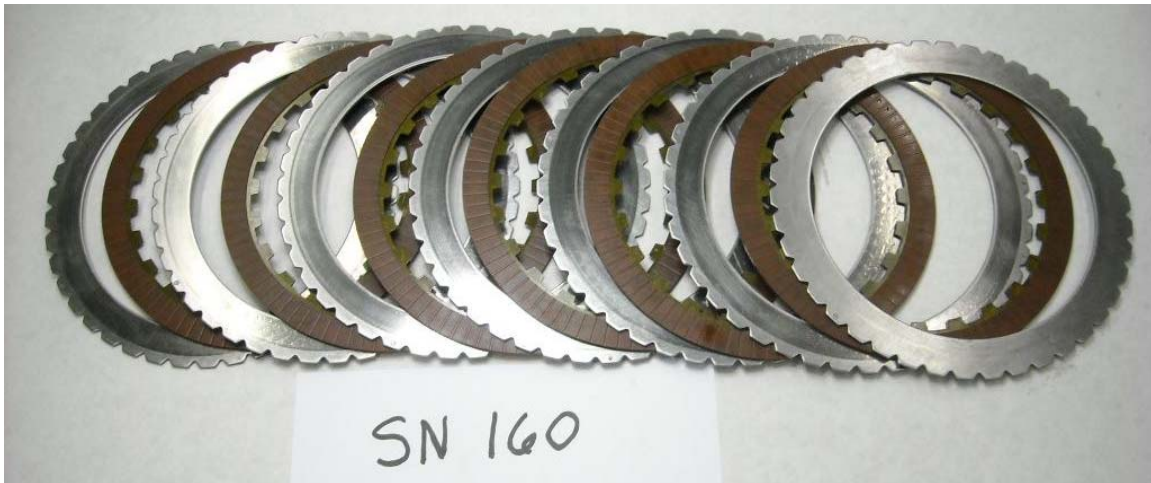
**SN160 C2 Friction Disk and Reaction Plates**

<b>C1 CLUTCH STEEL PLATES</b>	POLISHED WITH NO ABNORMAL WEAR
<b>C1 CLUTCH PAPER PLATES</b>	PLATE IDENTIFICATION NUMBERS VISIBLE WITH NO VISUAL WEAR OR DISTRESS
<b>C2 CLUTCH STEEL PLATES</b>	POLISHED WITH NO ABNORMAL WEAR
<b>C2 CLUTCH PAPER PLATES</b>	VERY SLIGHT DARKENING WITH PLATE IDENTIFICATION NUMBERS VISBLE
<b>C3 CLUTCH STEEL PLATES</b>	SLIGHTLY POLISHED WITH NO ABNORMAL WEAR
<b>C3 CLUTCH PAPER PLATES</b>	VERY SLIGHT DARKENING WITH PLATE IDENTIFICATION NUMBERS VISBLE
<b>C4 CLUTCH STEEL PLATES</b>	SLIGHTLY POLISHED WITH NO ABNORMAL WEAR
<b>C4 CLUTCH PAPER PLATES</b>	VERY SLIGHT DARKENING WITH PLATE IDENTIFICATION NUMBERS VISBLE
<b>C5 CLUTCH STEEL PLATES</b>	SLIGHTLY POLISHED WITH NO ABNORMAL WEAR
<b>C5 CLUTCH PAPER PLATES</b>	VERY SLIGHT DARKENING WITH PLATE IDENTIFICATION NUMBERS VISBLE
<b>THRUST WASHER</b>	POLISHED WITH SOME BLACK DEPOSITS
<b>BUSHINGS</b>	SLIGHT POLISHING WITH NO ABNORMAL WEAR
